Inspection Report

Property Address:
1234 Main Street
Anywhere Oregon 97202

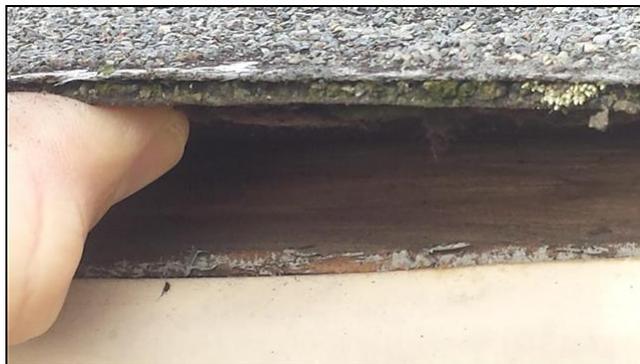
🔧 No drip edge flashing was installed at the time of the inspection. Lack of roof edge flashings leaves the edges of roof sheathing and underlayment exposed to the deteriorating effects of weather, with damage from moisture such as delamination and decay possible. I recommend having drip edge flashing installed by a qualified roofing contractor.

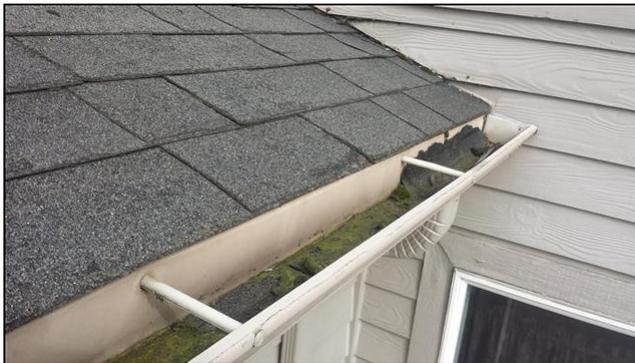
1.2 Roof Drainage Systems

The gutters are full of debris in areas and needs to be cleaned. The debris in gutters can also conceal rust, deterioration or leaks that are not visible until cleaned, and I am unable to determine if such conditions exist. I recommend cleaning of the gutters to prevent water intrusion into home.

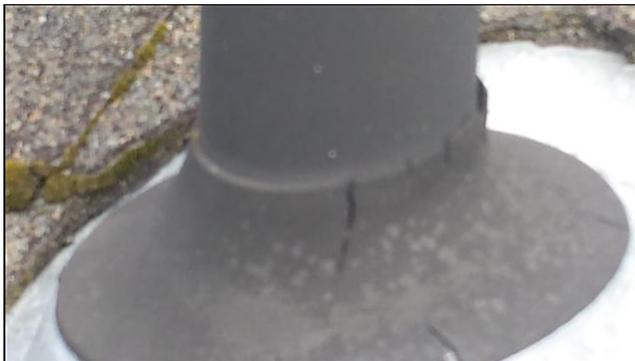
The rubber boot at a roof plumbing vent pipe was damaged and may allow moisture intrusion of the roof assembly. I recommend replacement by a qualified roofing contractor.

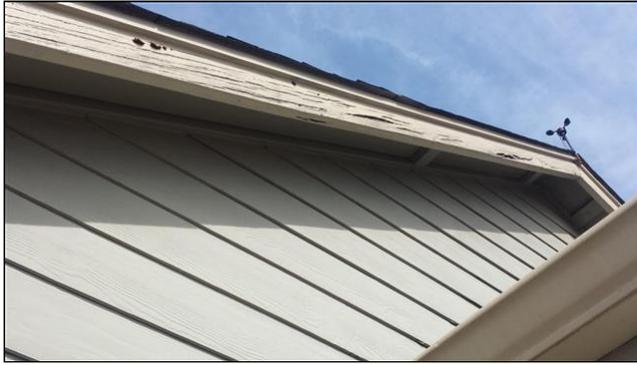
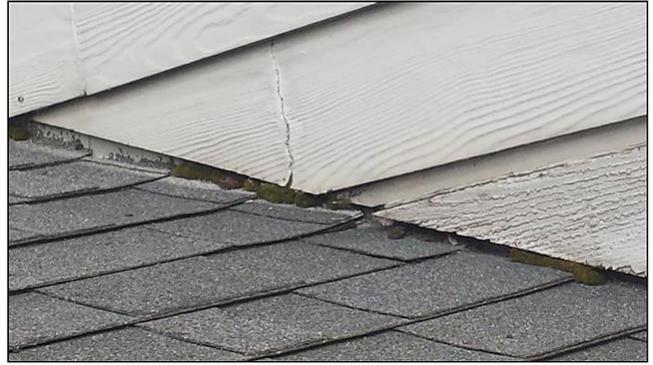
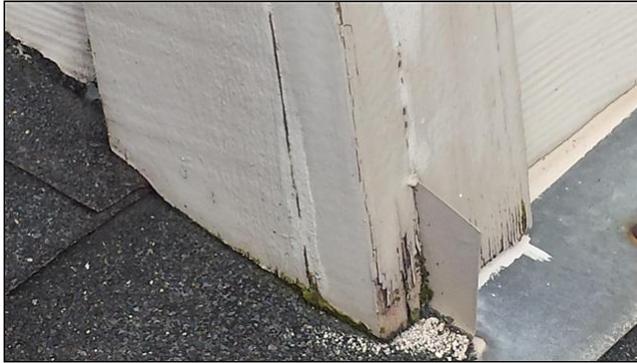
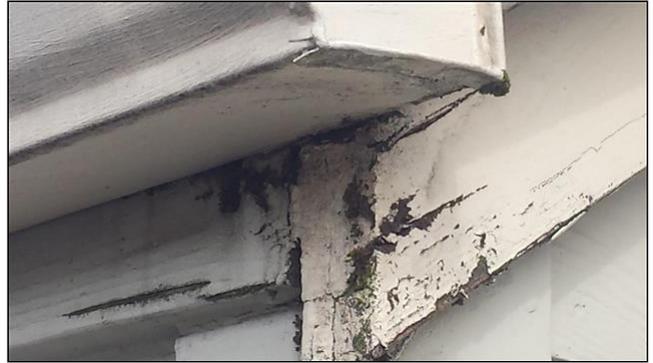
2.0 Wall Cladding Flashing and Trim

🔧 (1) The wood trim is deteriorated in various areas at the exterior. I recommend a qualified contractor correct as needed.

🔧 (2) Damage to exterior walls appeared to be the result of moisture contact from inadequate clearance from the roof-covering material. Good building practice requires a gap of 1.5 inches minimum between the bottom of exterior wall-covering material and the top of the roof-covering material to avoid damage from deterioration caused by moisture absorption. This damage will continue if this condition is not corrected. All work should be performed by a qualified contractor.

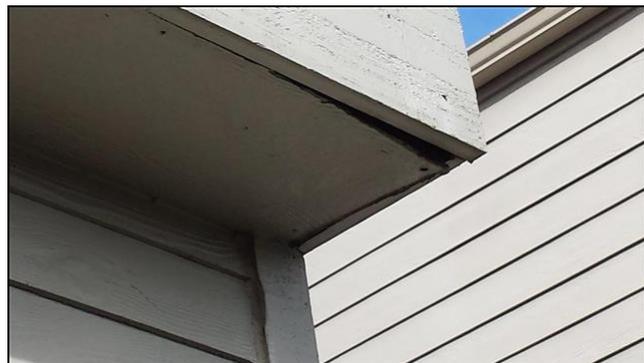
🔧 A gap between the fascia and roof sheathing exists which allows insects or water to enter into the house. This may cause damage to the structure of the build if left unrepaired. I recommend repair by a qualified contractor.

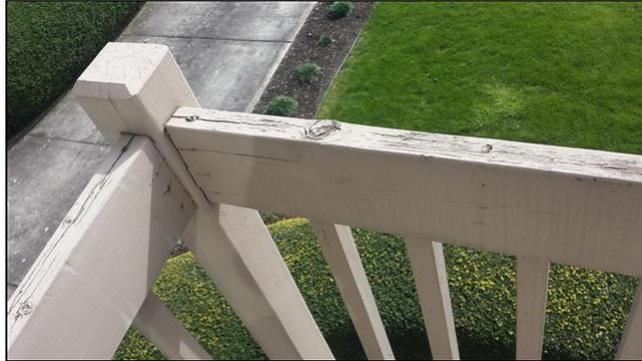
🔧 The guardrails on upper level balcony at the front of home is showing paint failing or peeling. This is a maintenance issue that can prevent further deterioration. A qualified contractor should repair or replace as needed.

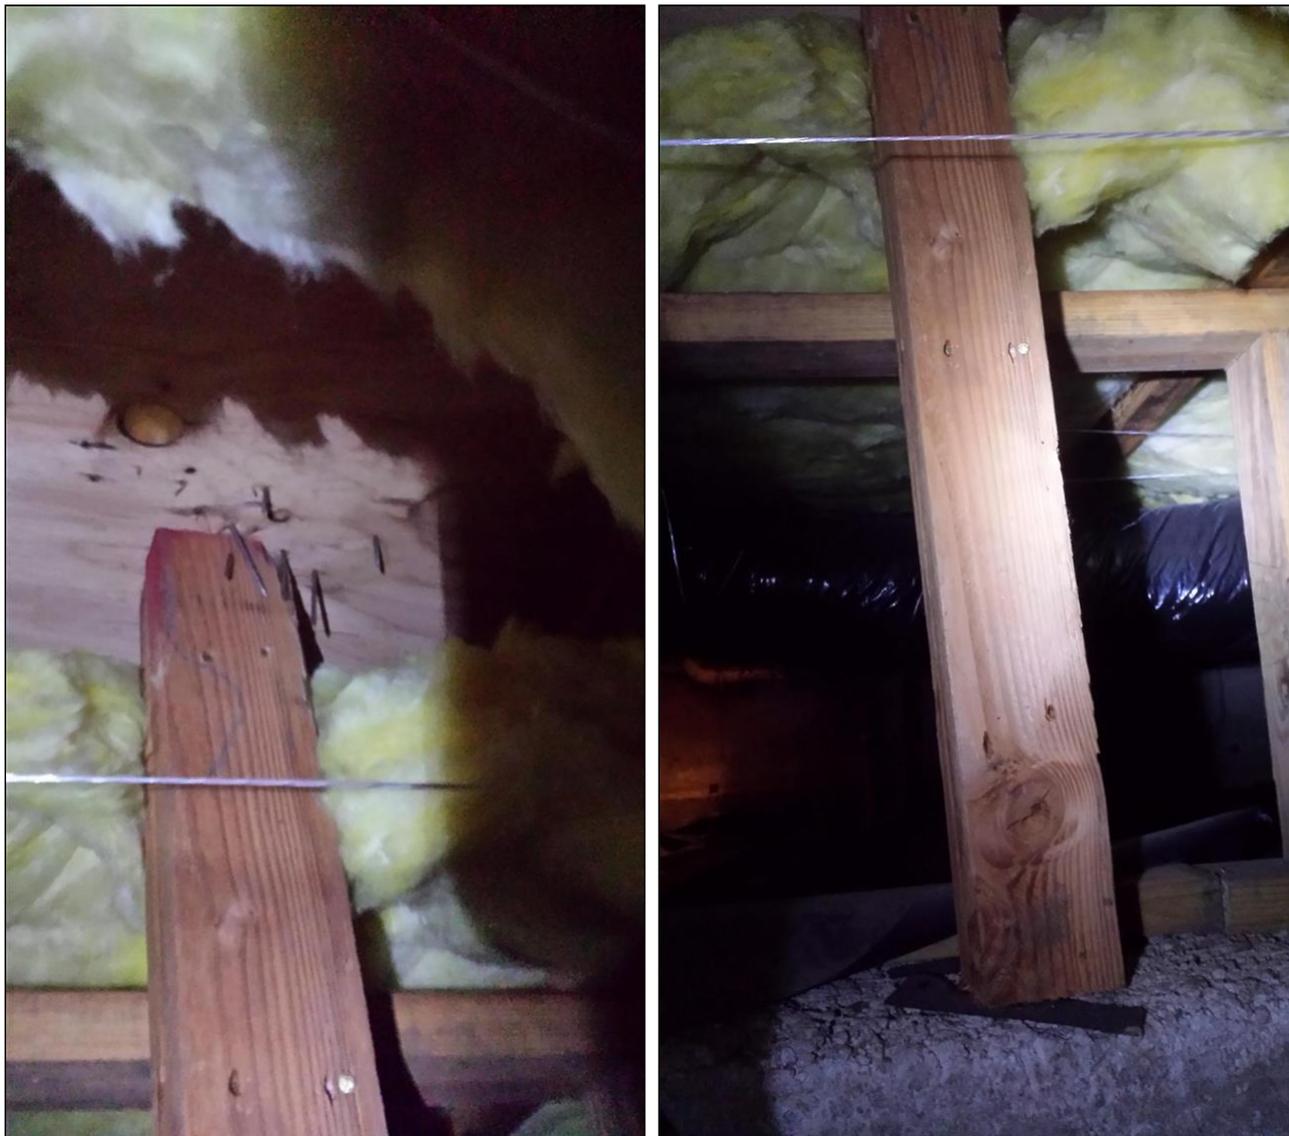
4.2 Columns or Piers

👉 The support post was not repaired according to standard practices in the crawlspace. No repairs are needed or foreseen at this time. This is my opinion and you should seek a second opinion by a qualified person.

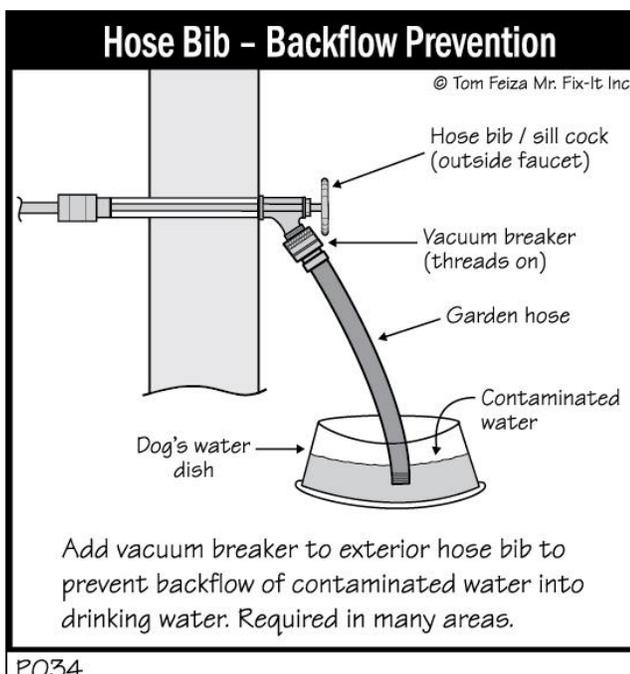
▲ (1) The hose bib does not have a vacuum breaker installed. The lack of a vacuum breaker may allow the water supply within the house to become contaminated. I recommend that a vacuum breaker be installed for your safety.

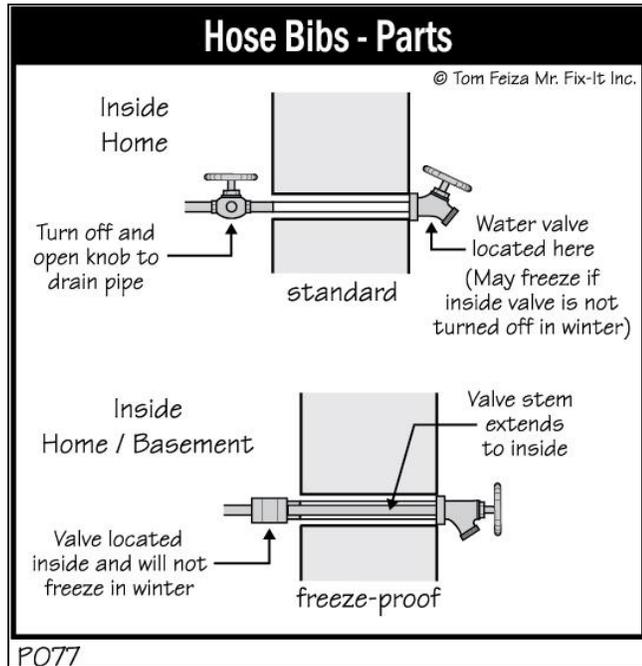
🔧 (2) The hose bib installed is not freeze proof, which can cause water to freeze within the pipes and cause damage. I recommend replacing the old hose bib with a freeze proof hose bib.

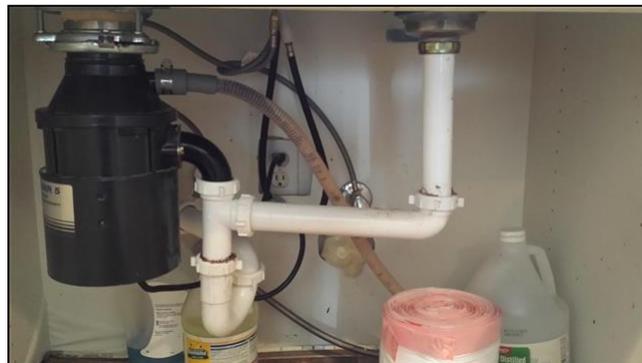
5.1 Plumbing Drain, Waste and Vent Systems

🔧 The waste line is leaking at the Kitchen sink. Repairs are needed to stop leaking water from damaging the cabinet bottom or to eliminate moisture that may contribute to fungi growth. A qualified licensed plumber should repair or correct as needed.

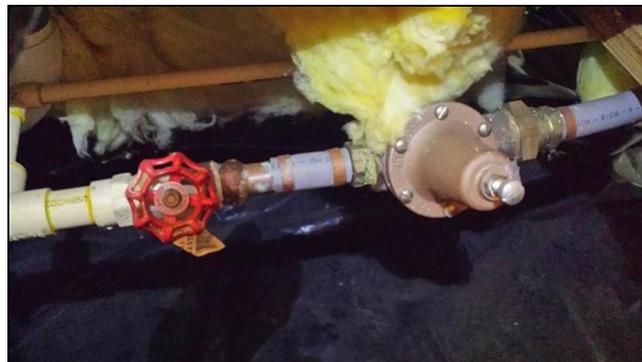
5.2 Main Water Shut-off Device (Describe location)

The main water shut off valve was located in the crawlspace in the downstairs hall closet near the access hatch. The valve has the red handle.

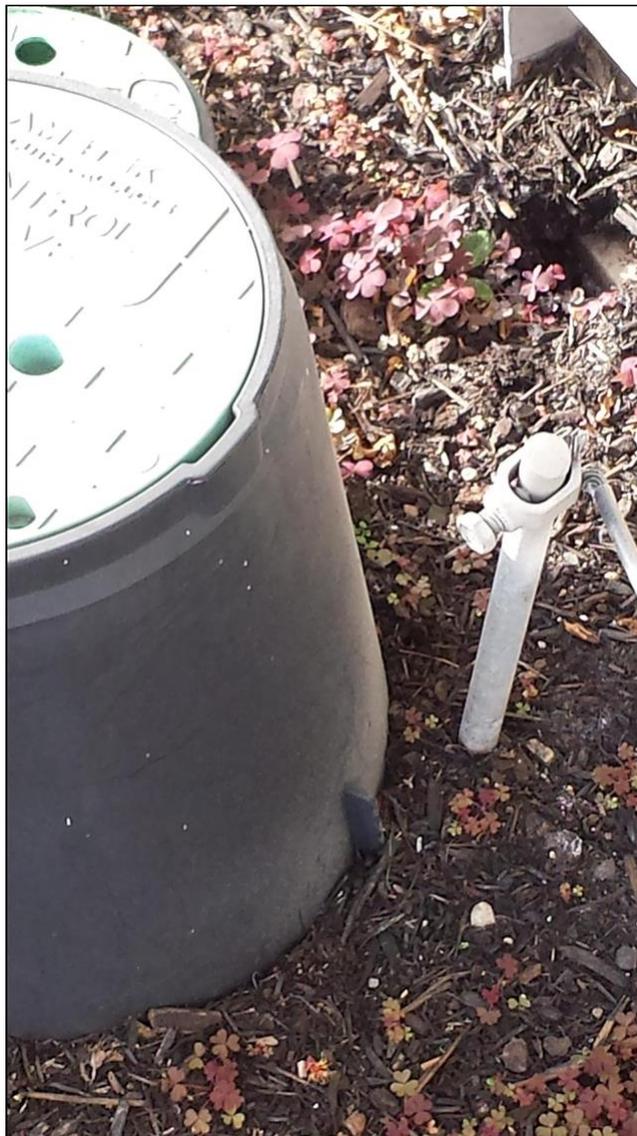
Service Grounding Electrode was a driven rod found on the southeast corner of the house. The rod should be completely driven into the ground. I recommend repair by a qualified contractor.

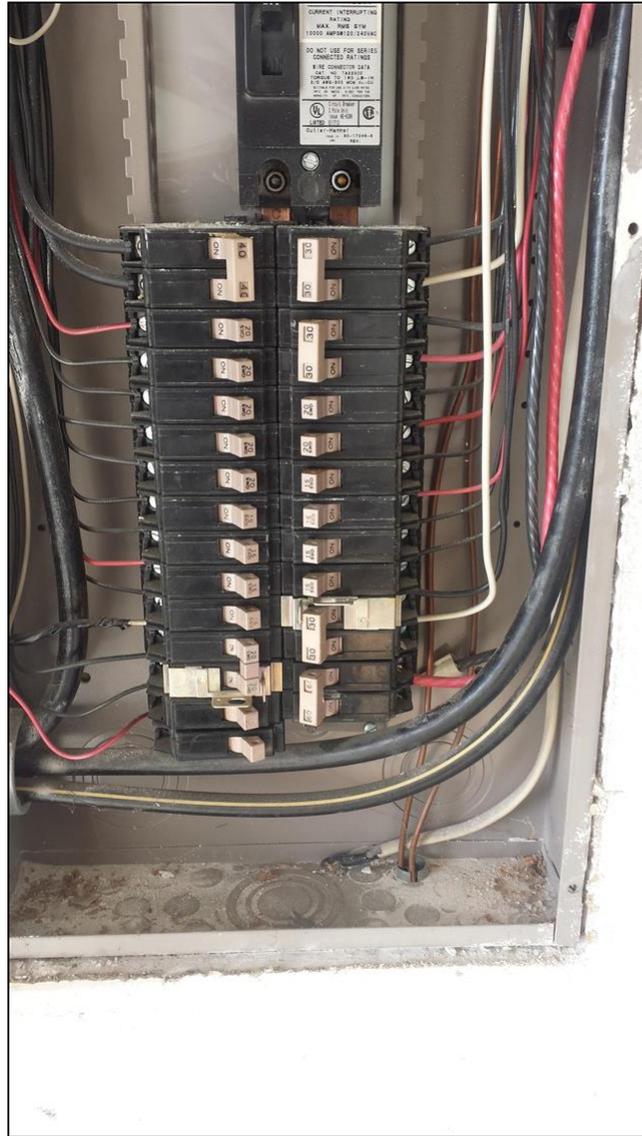
6.3 Branch Circuit Conductors, Overcurrent Devices and Compatibility of their Amperage and Voltage

🔧 Problem(s) discovered with Branch Circuits such as amateur wiring installation, and any other problems that an electrical contractor may discover while performing repairs need correcting. I recommend a licensed electrical contractor inspect further and correct as needed.

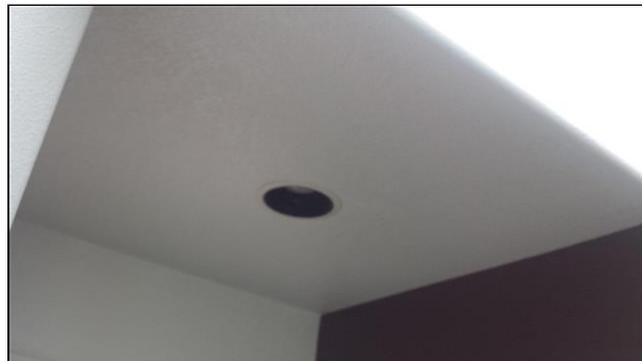
🔧 Multiple light fixtures do not work. Pictured location: hallway downstairs. Further inspection is needed by a qualified licensed electrical contractor.

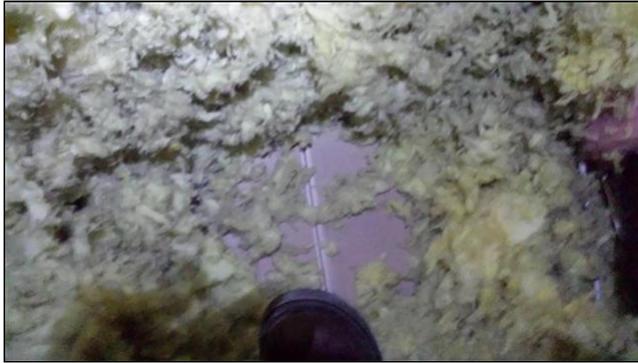
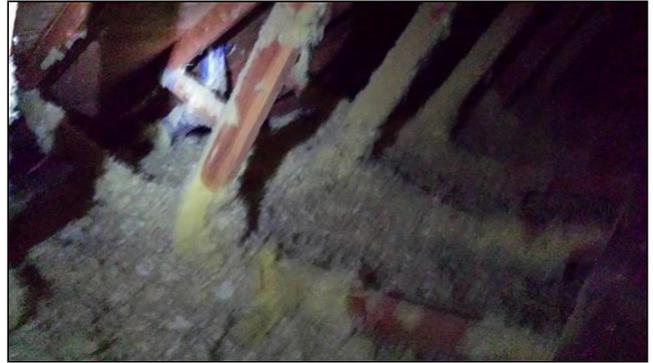
8.1 Insulation in Attic

The attic had rigid foam board panels with blown in fiberglass insulation over the top.

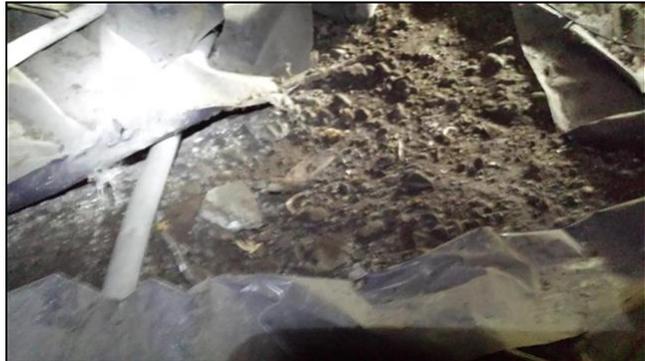
The vapor barrier (plastic) on the crawlspace ground is missing in areas. A vapor barrier provides added protection to the floor system from moisture or dampness that can enter from ground. A qualified person should repair or replace as needed.

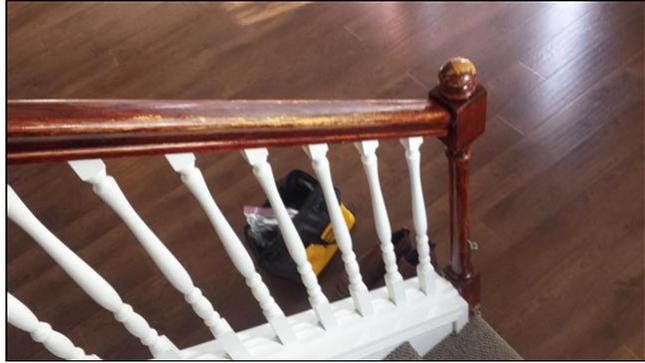
⚠ The hand/guard rail for the stairway is loose. A proper repair is needed to ensure stability or an injury might occur. A qualified licensed contractor should repair or replace as needed.

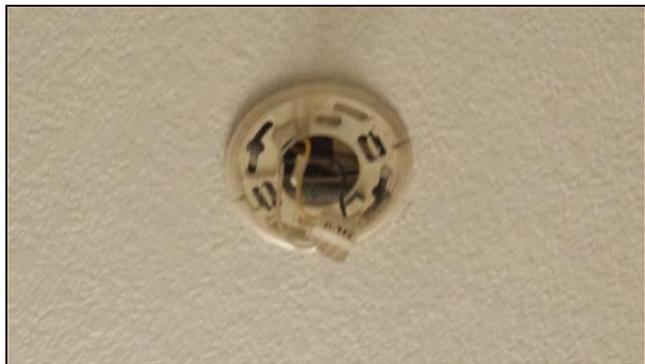
⚠ (2) Smoke detectors in this home were missing or poorly placed. I recommend that smoke detectors be placed in accordance with generally-accepted modern standards to protect sleeping areas. This is a life-safety issue.

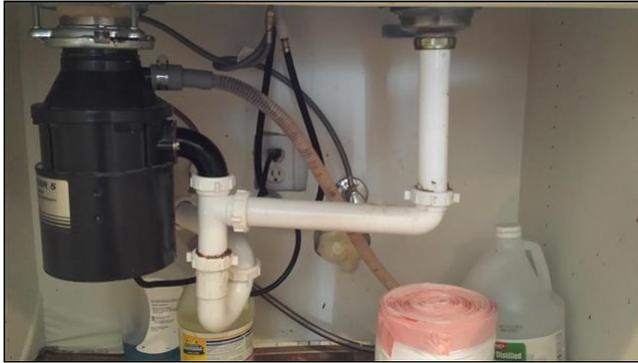
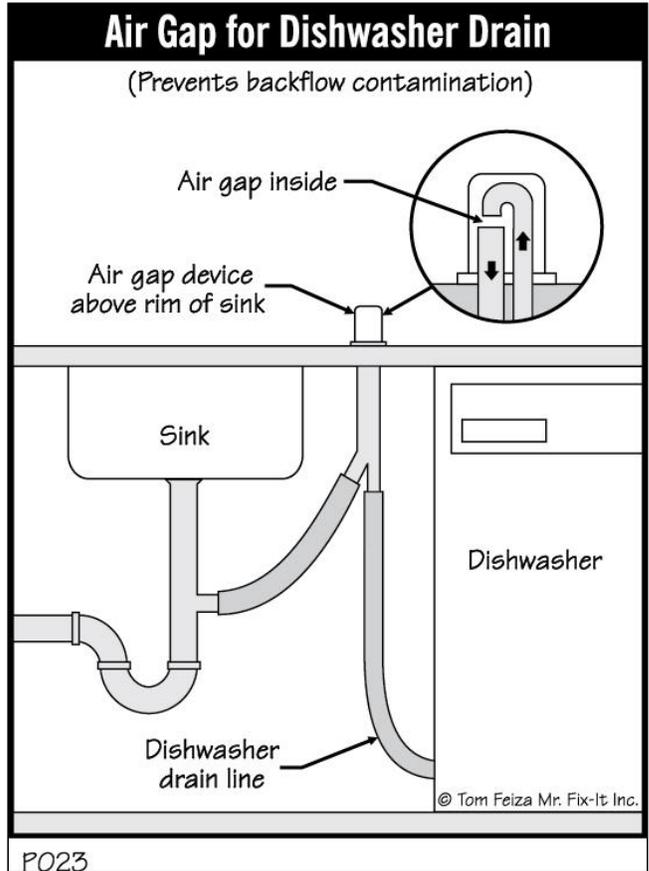
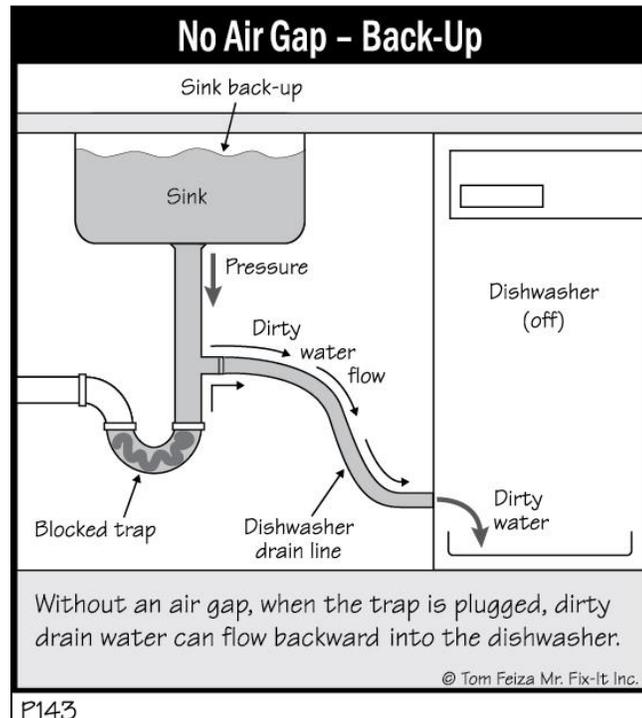
10.0 Dishwasher

🔧 The dishwasher had an improper anti-siphon device installed in the drain line. Anti-siphon devices are installed to prevent wastewater from the dishwasher from being siphoned back into the dishwasher and contaminating its contents. I recommend service by a qualified plumbing contractor.
